Application to Amend a Planning Permit \$72

| Planning Application | PLA0044/23 |
|---|---|
| Address: | 14 BURTONWOOD CRT, NEERIM SOUTH |

REQUEST TO CHANGE SUBDIVISION LAYOUT (Condition 2.) and OBTAIN WRITTEN CONSENT FROM RESPONSIBLE AUTHORITY

Preliminary Arboricultural Assessment, Tree Impact Assessment & Tree Management Plan. 14 Burtonwood CT, Neerim South 3831

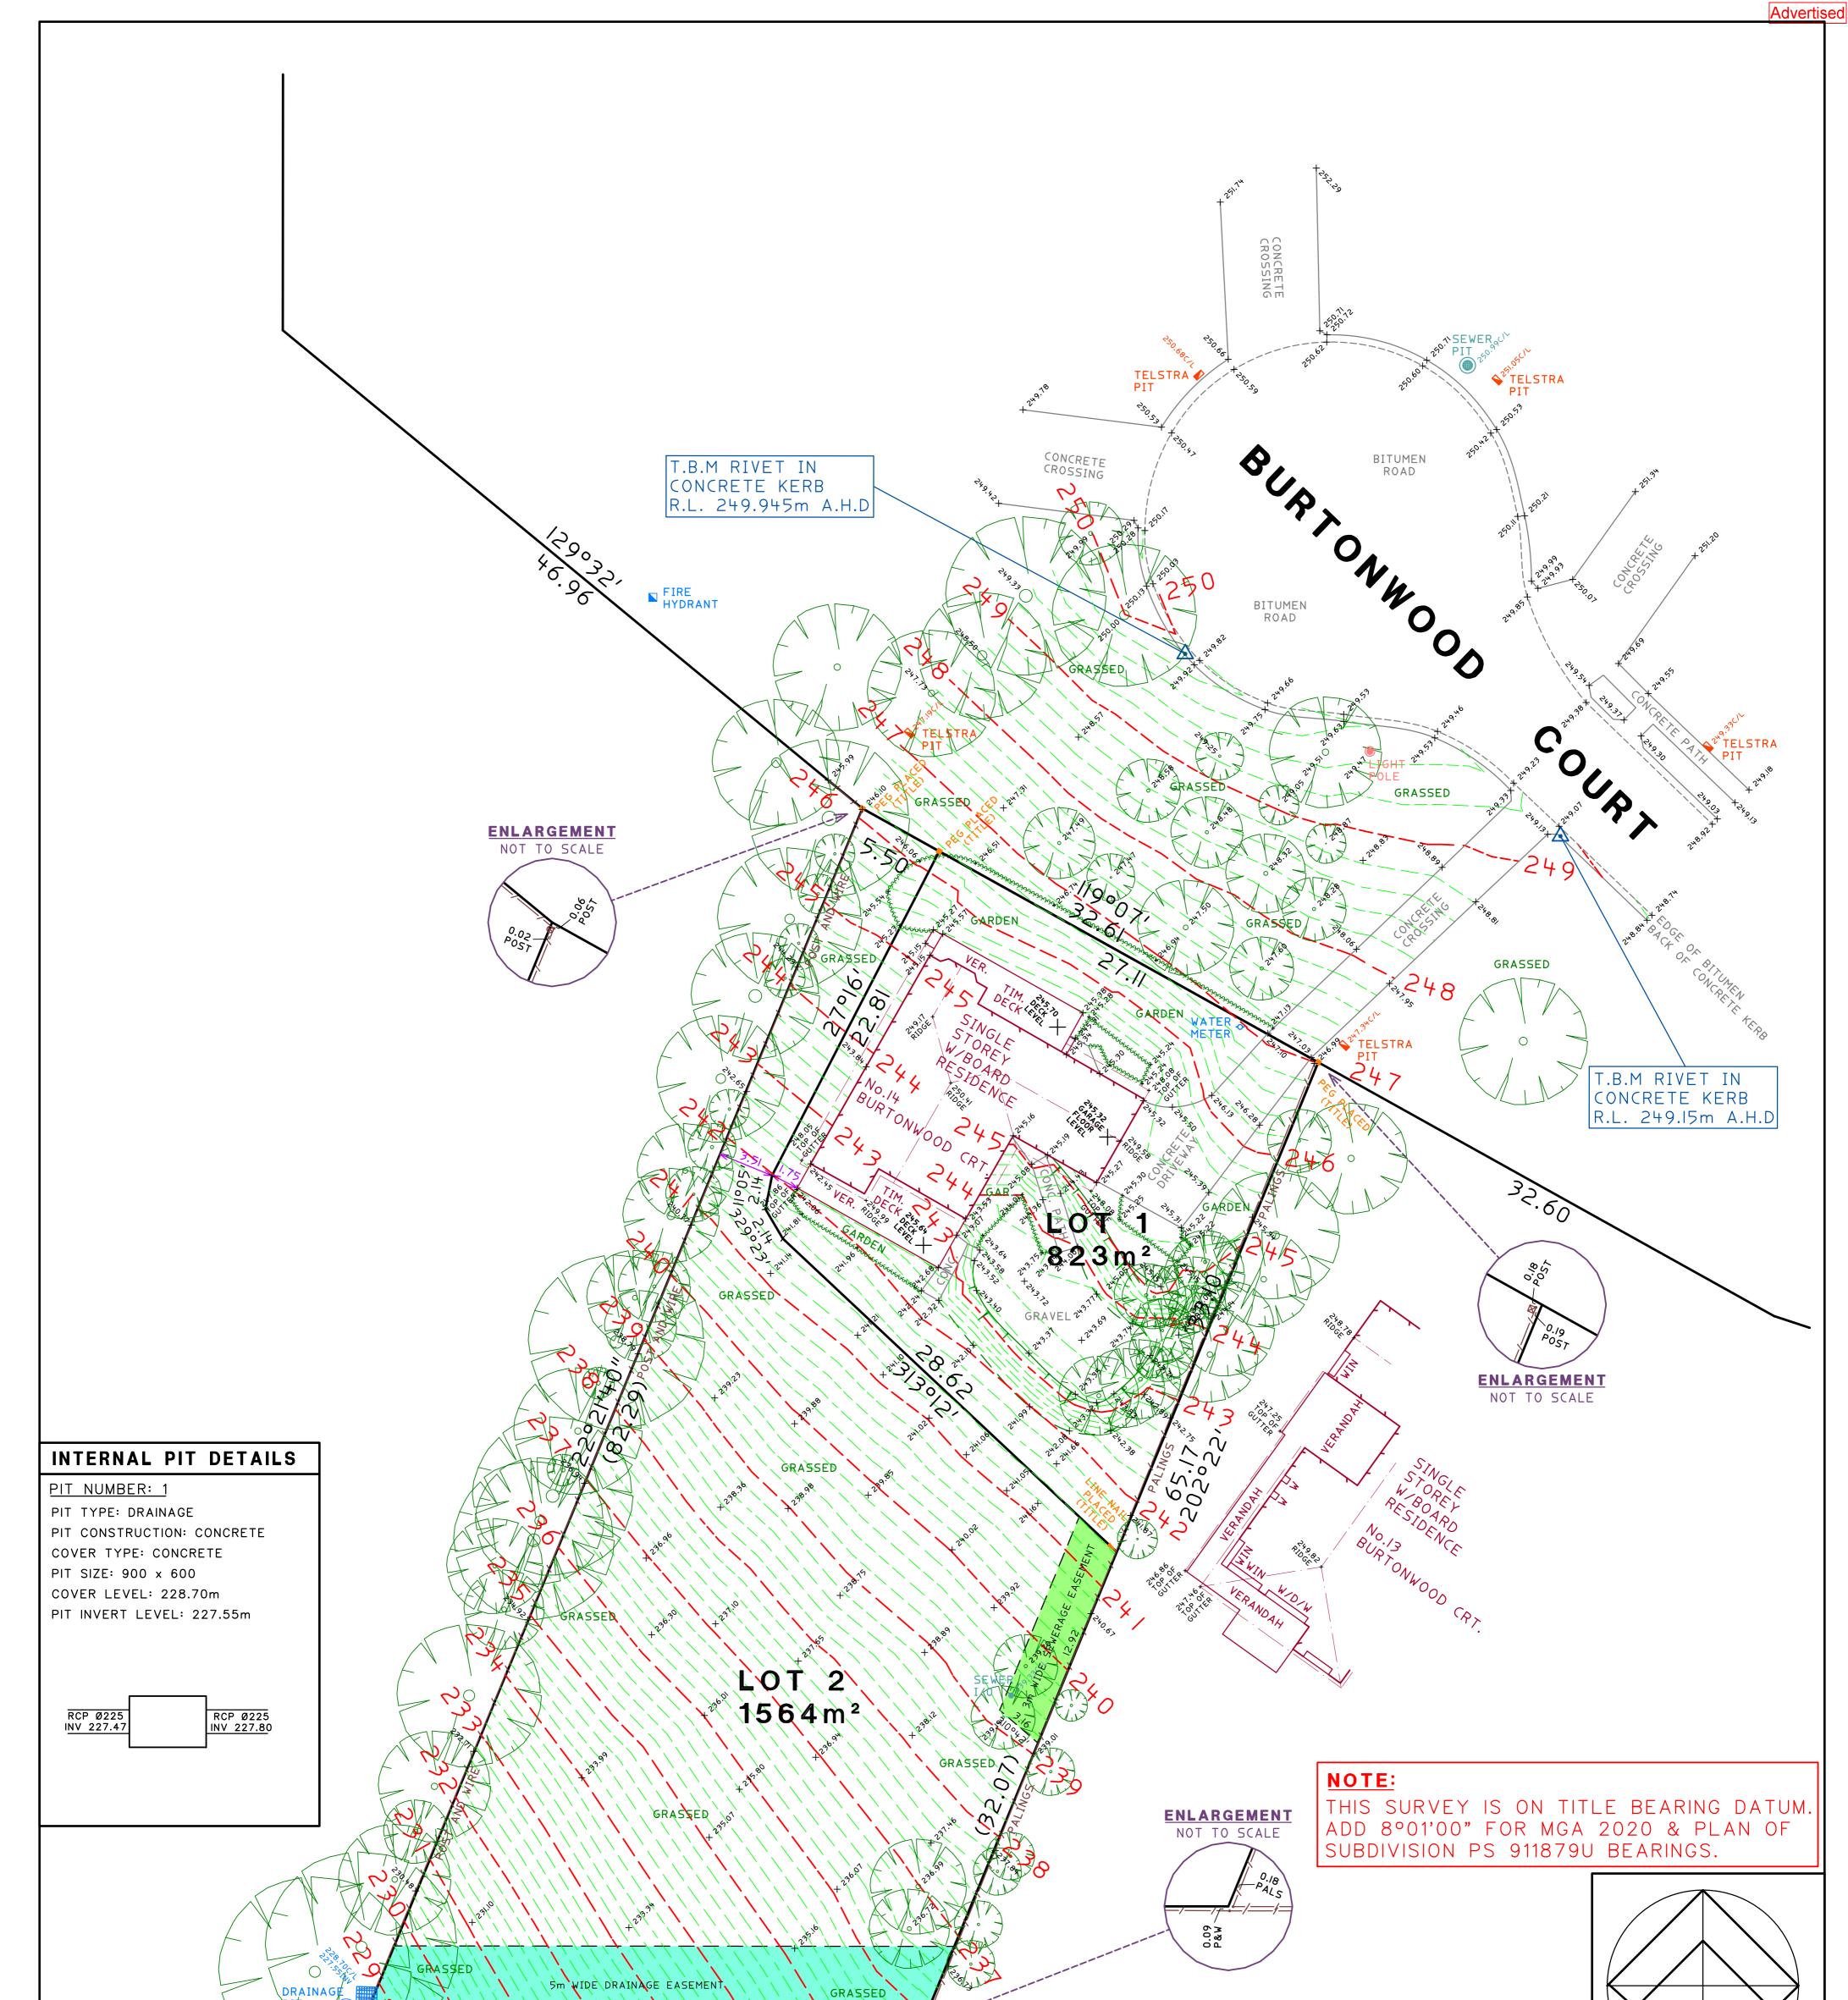
| POST AND WIRE POST AND WIRE | $\frac{35m}{270^{\circ}03'_{23}} \xrightarrow{\text{Post and wire}} \xrightarrow{23^{\circ}} $ | | TITLE NORTH |
|---|---|---|--|
| ENLARGEMENT NOT TO SCALE | | LEVELS ARE CONTOUR INT | ERVAL: 0.2m |
| NOTATIONS: THIS RE-ESTABLISHMENT SURVEY RE-ESTABLISHES THE LAND UNDER SURVEY BASED ON INFORMATION CONTAINED ON THE CERTIFICATE OF TITLE, AND DOES NOT ATTEMPT TO DETERMINE ANY POSSESSORY RIGHTS TO LAND FENCED OFF BY THE LAND UNDER SURVEY OR ABUTTING PROPERTIES. SHOULD THERE BE ANY QUERIES IN THIS REGARD THE SURVEYOR SHOULD BE CONSULTED. STRUCTURES BELOW THE SURFACE (IF ANY) INCLUDING FOOTINGS PROJECTING INTO THE SITE FROM ADJOINING PROPERTIES HAVE NOT BEEN LOCATED BY THIS SURVEY. WE HAVE NOT EXCAVATED THE SITE TO DETERMINE THEIR EXISTANCE (IF ANY). FENCE OR BUILDING POSITIONS SHOWN NEAR BOUNDARIES ARE NOT NECESSARILY TO SCALE AND EXAGGERATED FOR CLARITY. | IMPORTANT BEFORE ANY DEVELOPMENT DESIGNS OR WORKS ARE STARTED WHERE OCCUPATION (ie:- FENCES AND BUILDINGS) ENCROACHES ONTO THE SUBJECT SITE. THE LAND OUTSIDE OF OCCUPATION MAY NOT BE RECOVERABLE AS POSSESSORY RIGHTS MAY HAVE BEEN PASSED ONTO ADJOINING OWNERS. TITLE DIMENSIONS SHOULD NOT BE ASSUMED UNTIL THE ABOVE ISSUES ARE RESOLVED. SHOULD THERE BE ANY QUERIES THE LICENSED SURVEYOR SHOULD BE CONSULTED. | DATE OF SUF | HMENT DATUM: RE 68297 RVEY: 13.01.2021 UPDATED 30.10.2024 UPDATED 28.11.2024 KAS / SAC / APB @ A1 |

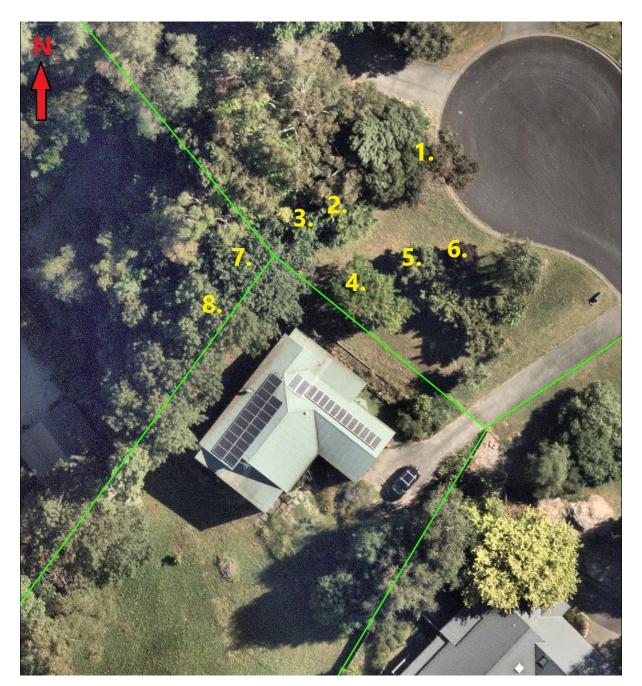
Figure 1: Site map illustrating tree numbers and property boundaries (NearMap 2025)

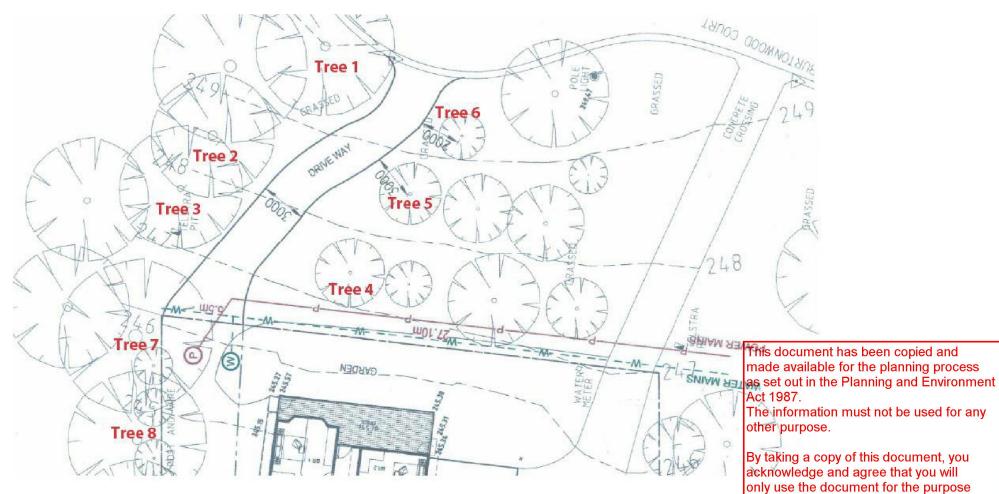
Figure 2: Site plan supplied by client and surveyor (P.Nolan 2025; Edited t

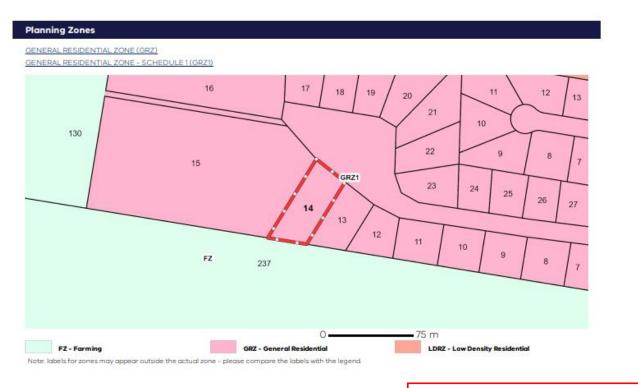
Figure 3: Subject site boundary and zoning (VicPlan 2025)

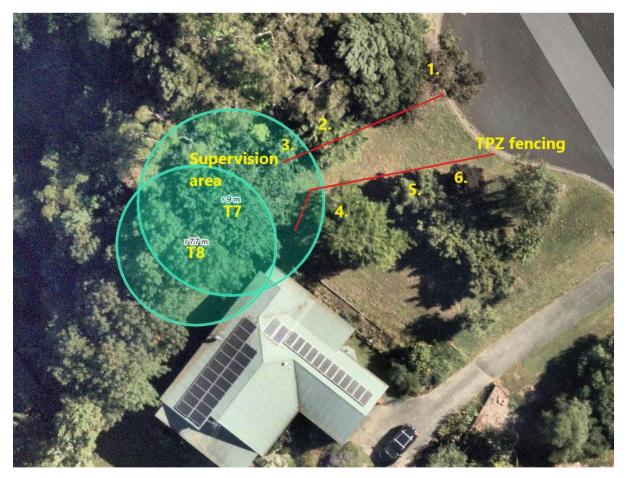
Figure 4: Map of TPZ fencing and the areas to supervise excavation (NearMap 2025)

The following is recommended for tree 7:

- 1. Any excavation required within the tree protection zones of tree 7 is to be supervised by a nominated project arborist.
- 2. Any roots discovered during the excavation process are to be measured, documented, photographed and then pruned by a qualified arborist using a reciprocating saw, at 90-degree angles to minimise the cut surface area.
- 3. Follow all general and tree specific conditions outlined in the tree management plan.
- 4. The owner of trees 7 and 8 is notified of the proposed work,
